# PROPERTY INSPECTION REPORT

Concerning: 6917 Surrey Dr. N.E.

By: HomeCheck TREC Sample Thursday, January 31, 2019

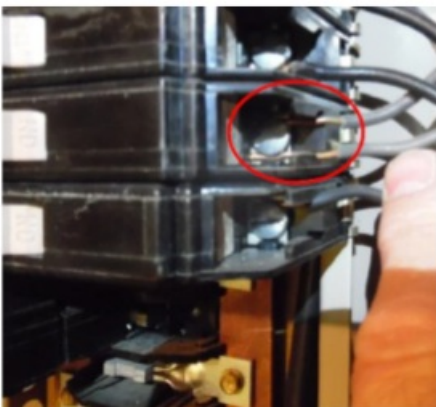
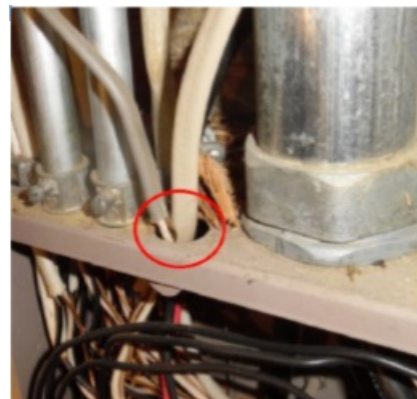
### 6.1 Branch Circuits, Connected Devices, and Fixtures

Branch Wire is marginal, would need to have Double tapping and appears undersized for this unit. Recommend installing additional receptacles/breakers In addition Open wiring not enclosed in appropriate junction boxes. Solid Strand Aluminum Branch Circuit Wiring Present: Can't Verify

Type of Wiring: Copper

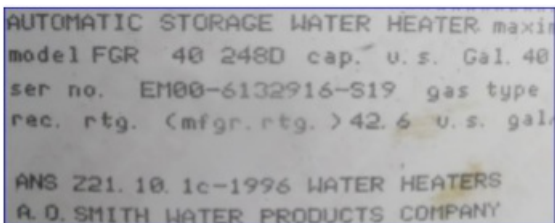
### 9.0 Water Heating Equipment

The manufacturer of the water heater is A.O. Smith. The Manufacture Date is 2000 so the unit is 18 years old and is near the end of life.

Type of Water Heater: Tank Water Temperature Degrees Fahrenheit: Unknown

Energy Sources: Natural Gas

Capacity: 40 Gallons
